THE ROCK PONDS ECOSYSTEM RESTORATION PROJECT – A TRUE MOSAIC OF HABITATS FOR TAMPA BAY

Brandt F. Henningsen, Ph.D., SWIM - SWFWMD

Surface Water Improvement
and Management (SWIM)
Program of the Southwest
Florida Water Management
District

Design Consultants: Scheda
Ecological Associates, Inc. and
5M Civil LLC

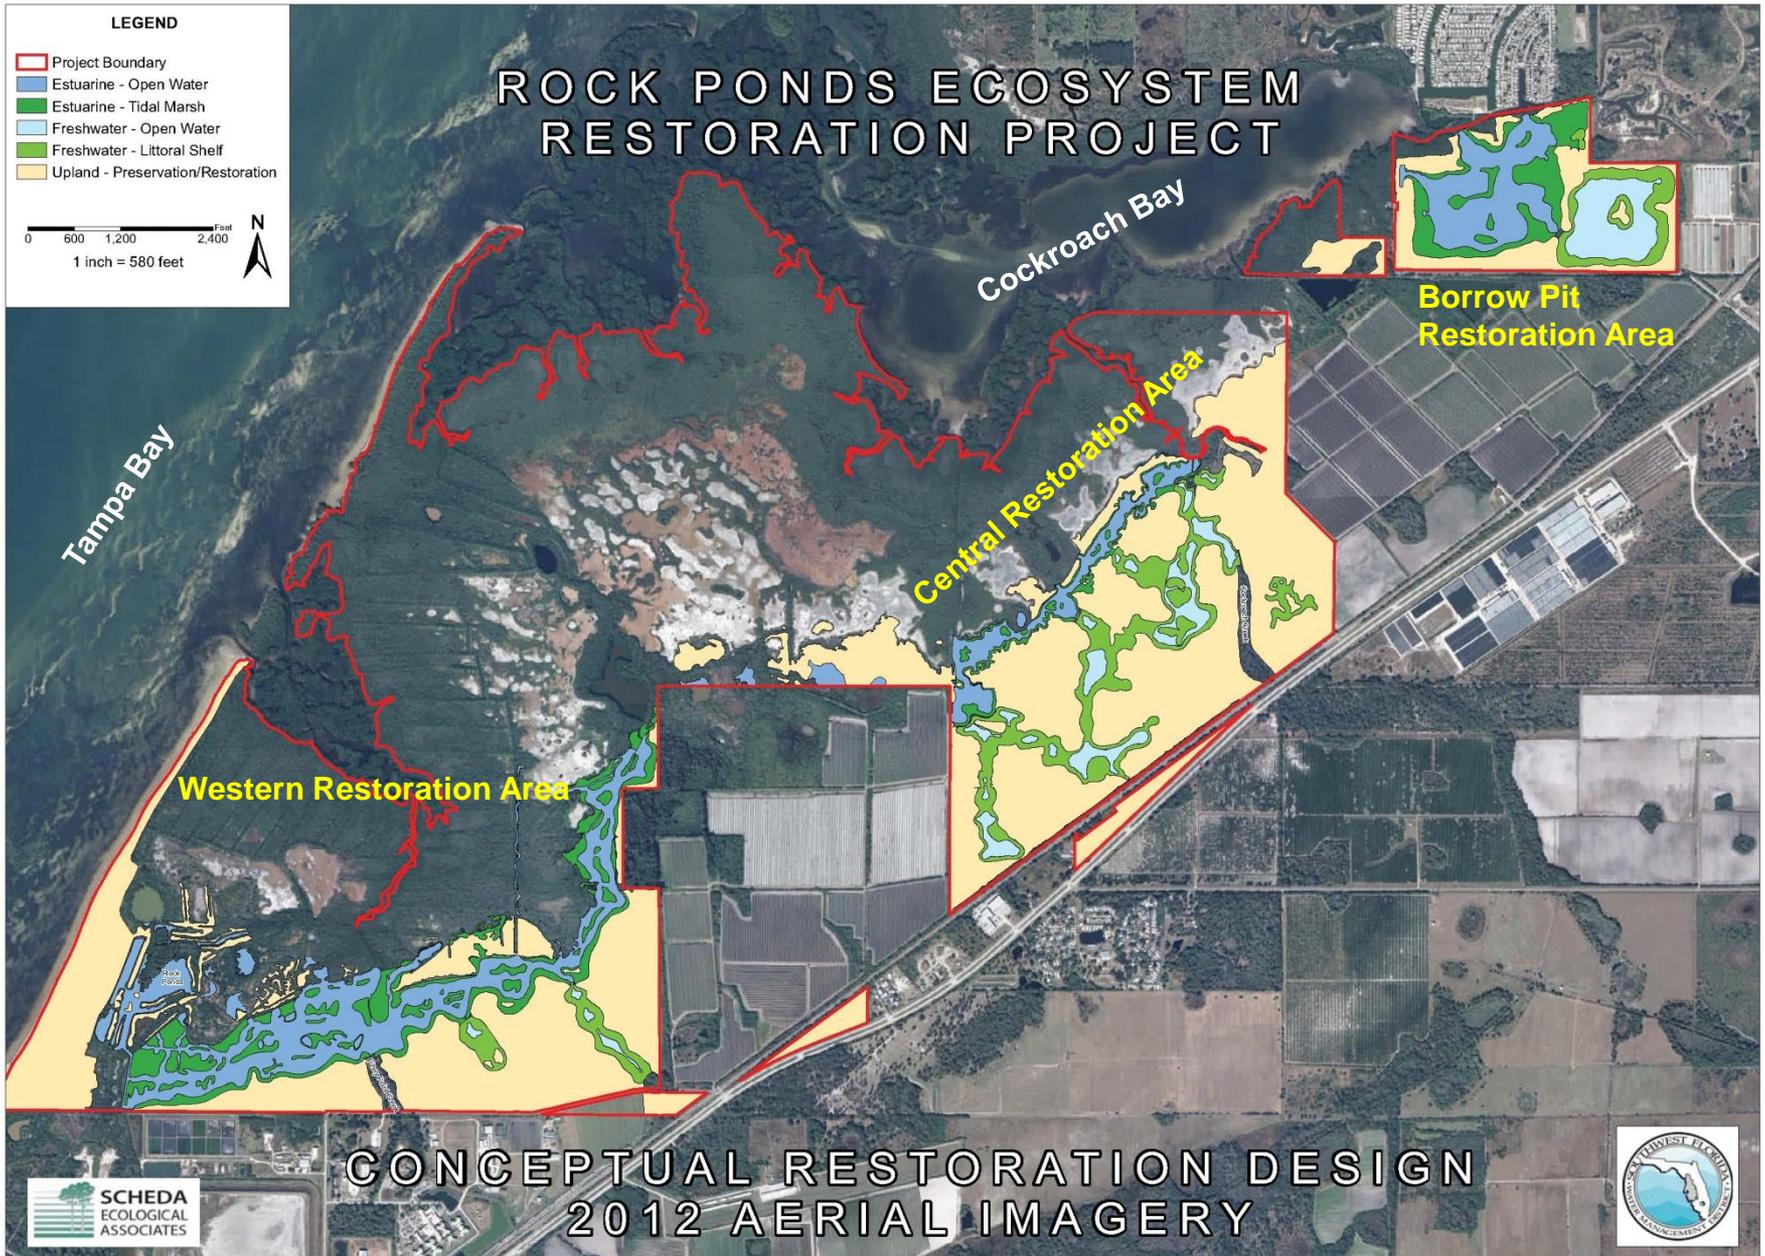
Figure 3. Rock Ponds Ecosystem Restoration Project Plans (Uplands + Wetlands)

Rock Ponds Design Statistics:

Upland Enhancement/Restoration...645 ac
Wetland Enhancement/Restoration..398 ac
1043 ac total -- over 1.6 square miles

Total Length of New Shoreline....85,590 ft.
(16.2 miles - a round trip on Howard Frankland Bridge
between Tampa and St. Petersburg)

Total Number of Plants Installed.....972,127

Total Volume of Dirt Moved...1,600,000 CY
(Equivalent to dirt stacked 611' high on a
football field!!!)

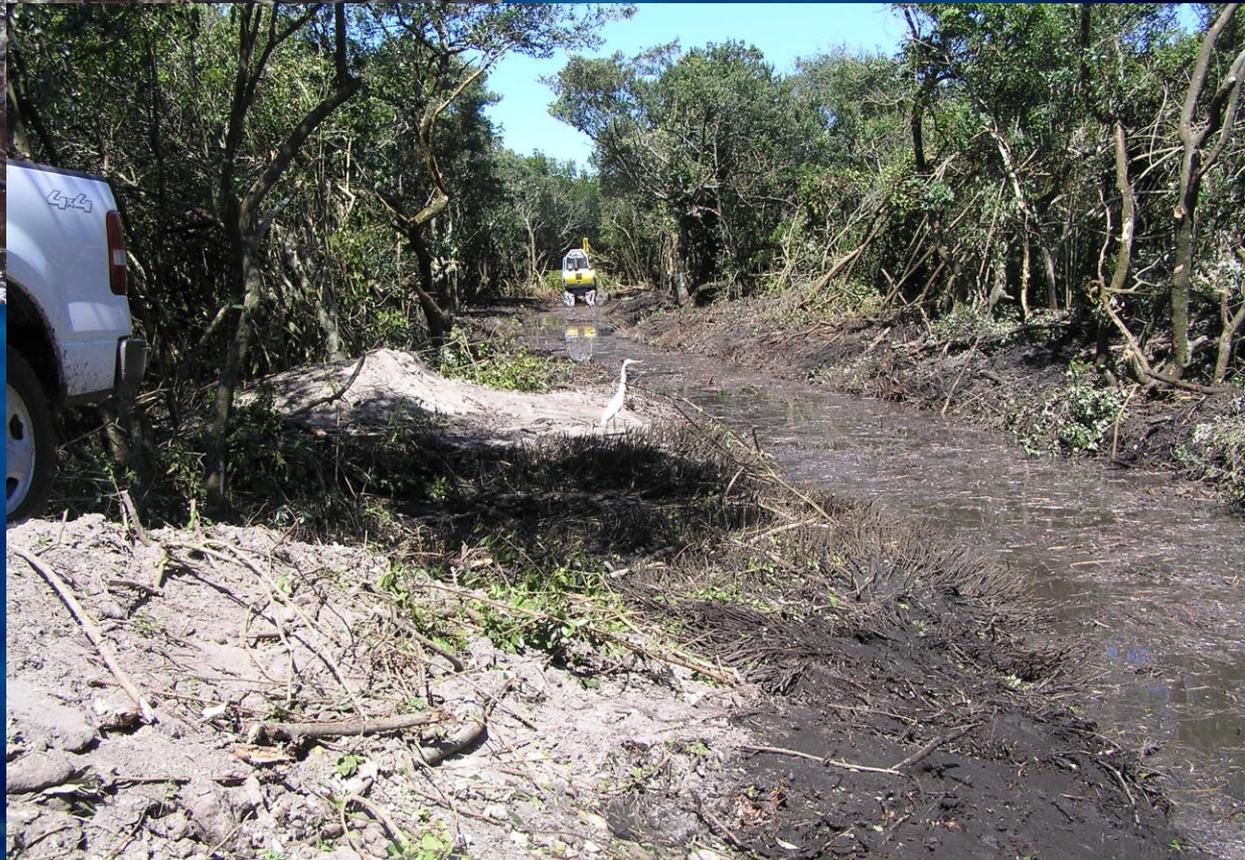
Piney Point Creek
Mid-Restoration
via Hillsborough
County "Menzi Muck"
Machine

“Menzi Muck”
restoring Piney
Point Creek

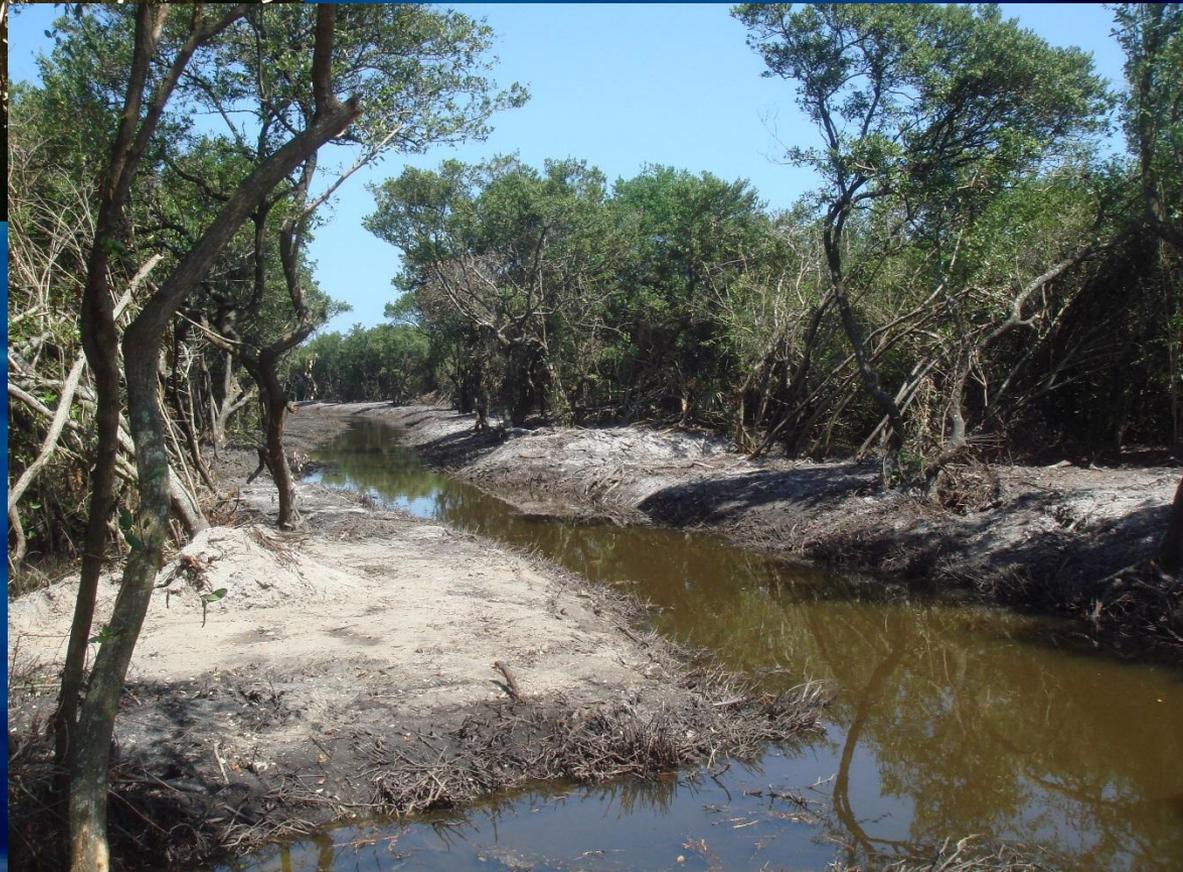
Piney Point
Creek “restored”,
prior to planting

“Road-to-Nowhere”: 0.5 mile long fill pad through mangroves excavated and contoured into a sinusoidal tidal channel (cross-linking with mosquito ditches)

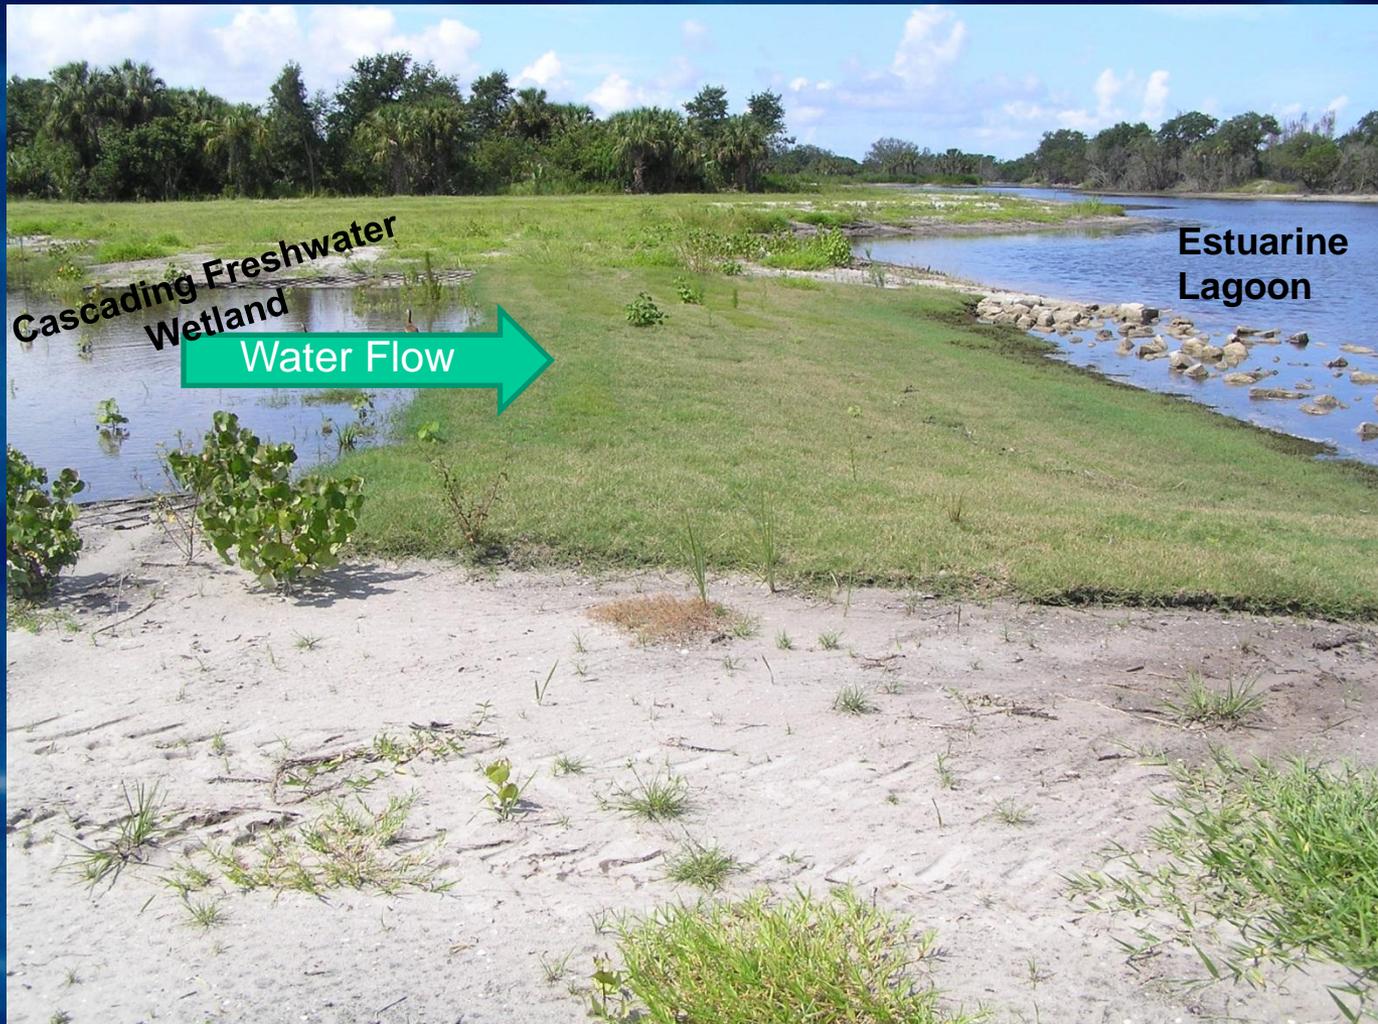
Weirs Part of Cascading Freshwater
Wetlands Draining to Intertidal Lagoons

Geoweb Weir with Seashore Paspalum sod

Weir "Blends In" – Not Obvious – Provides Habitat

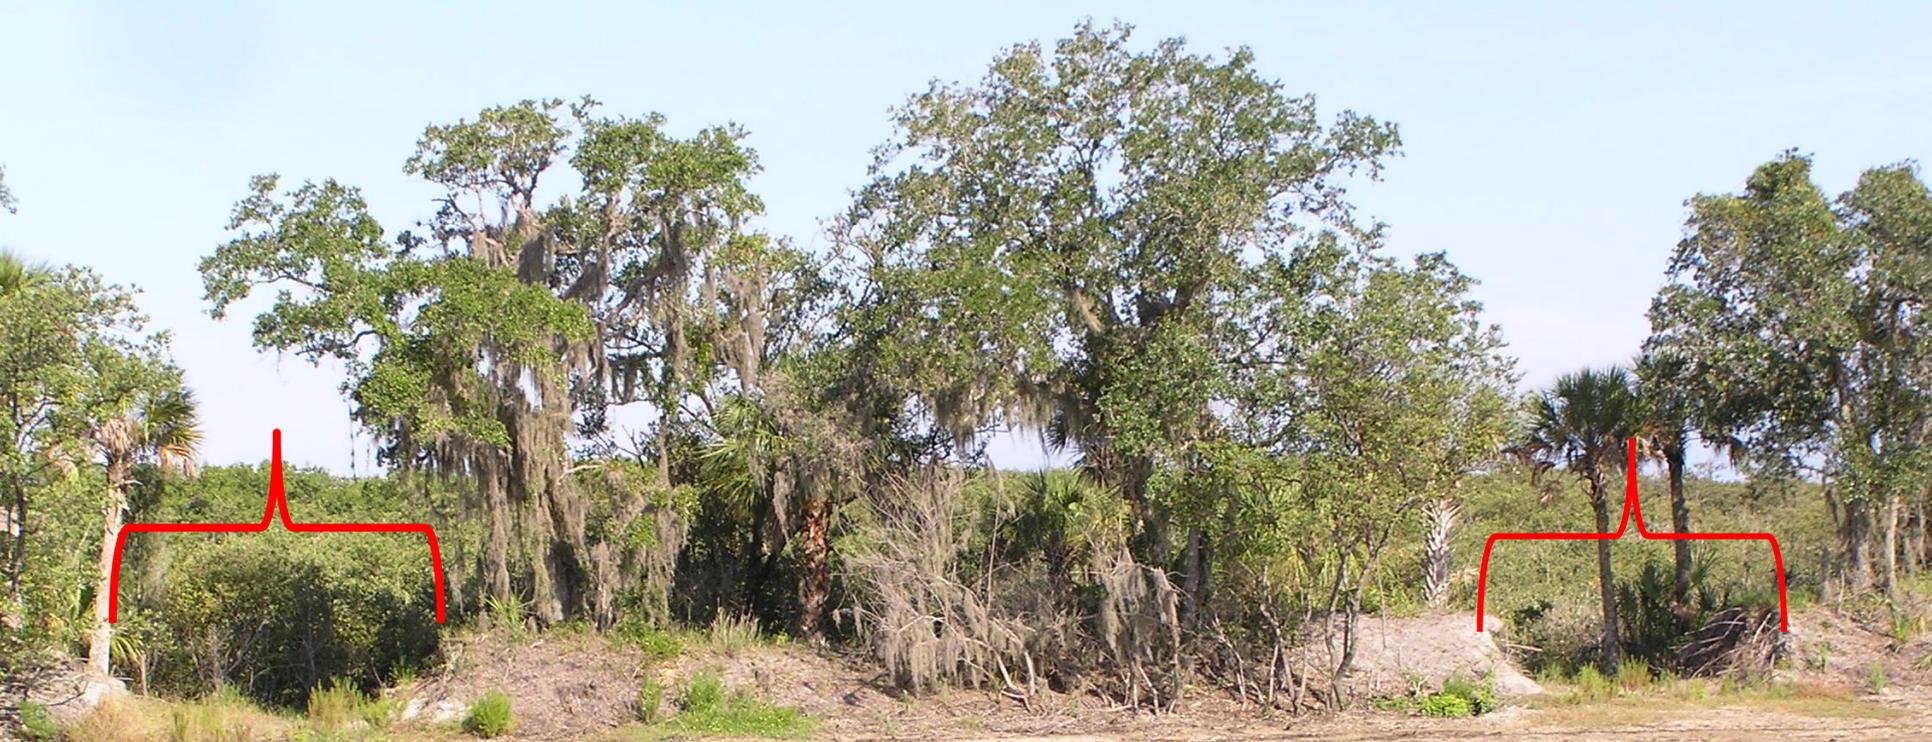
(Agricultural) Berm Breaches to Help Restore Area's Hydrology

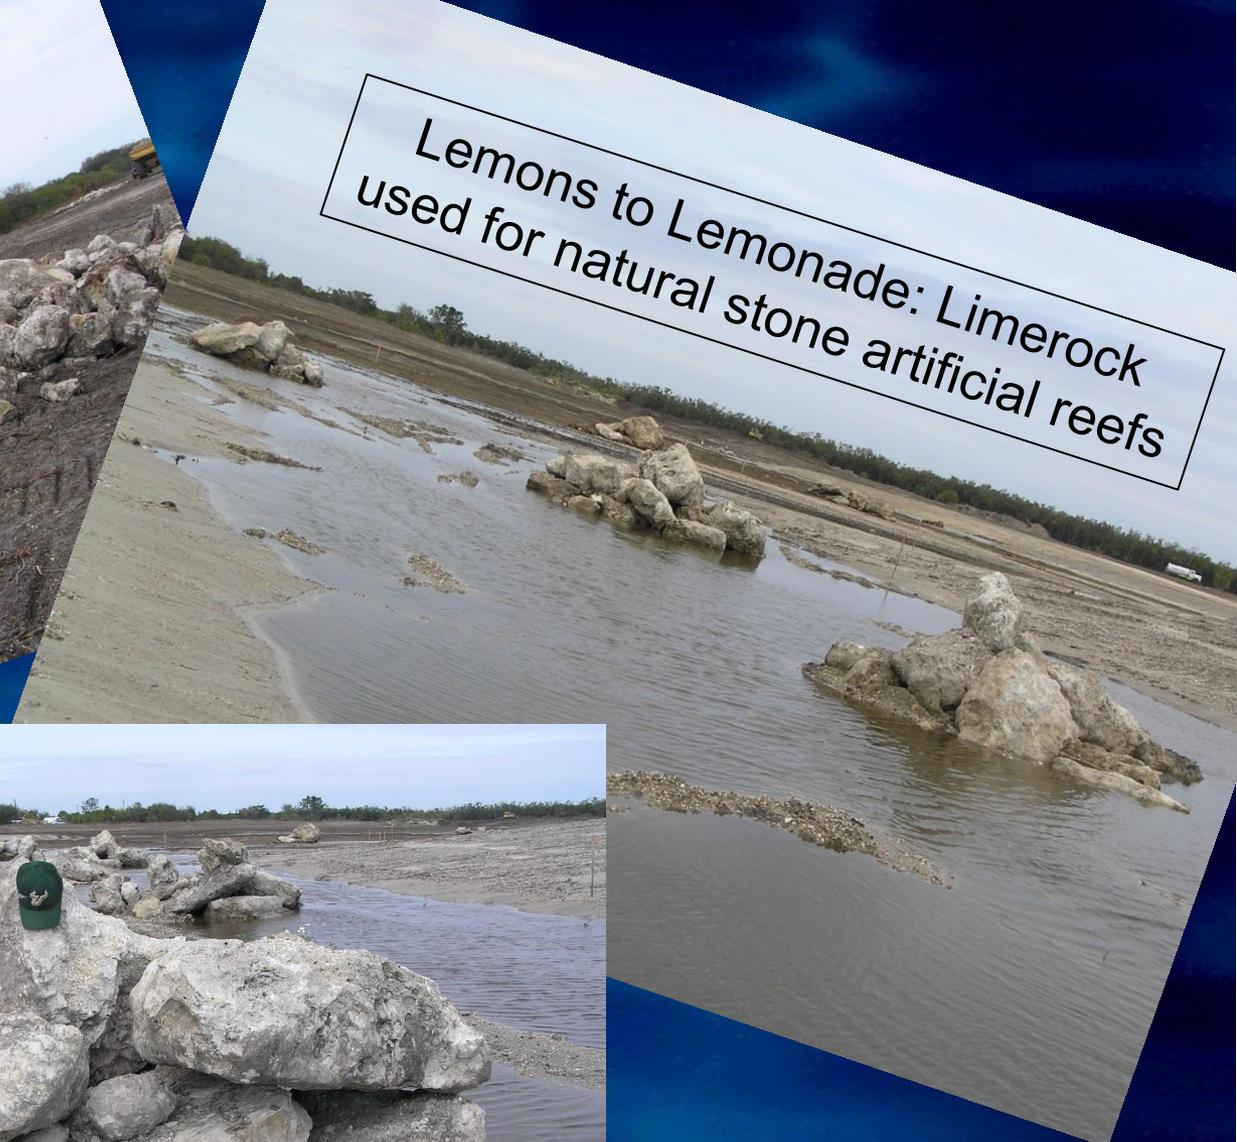
Limerock hindered excavation

Lemons to Lemonade: Limerock used for natural stone artificial reefs

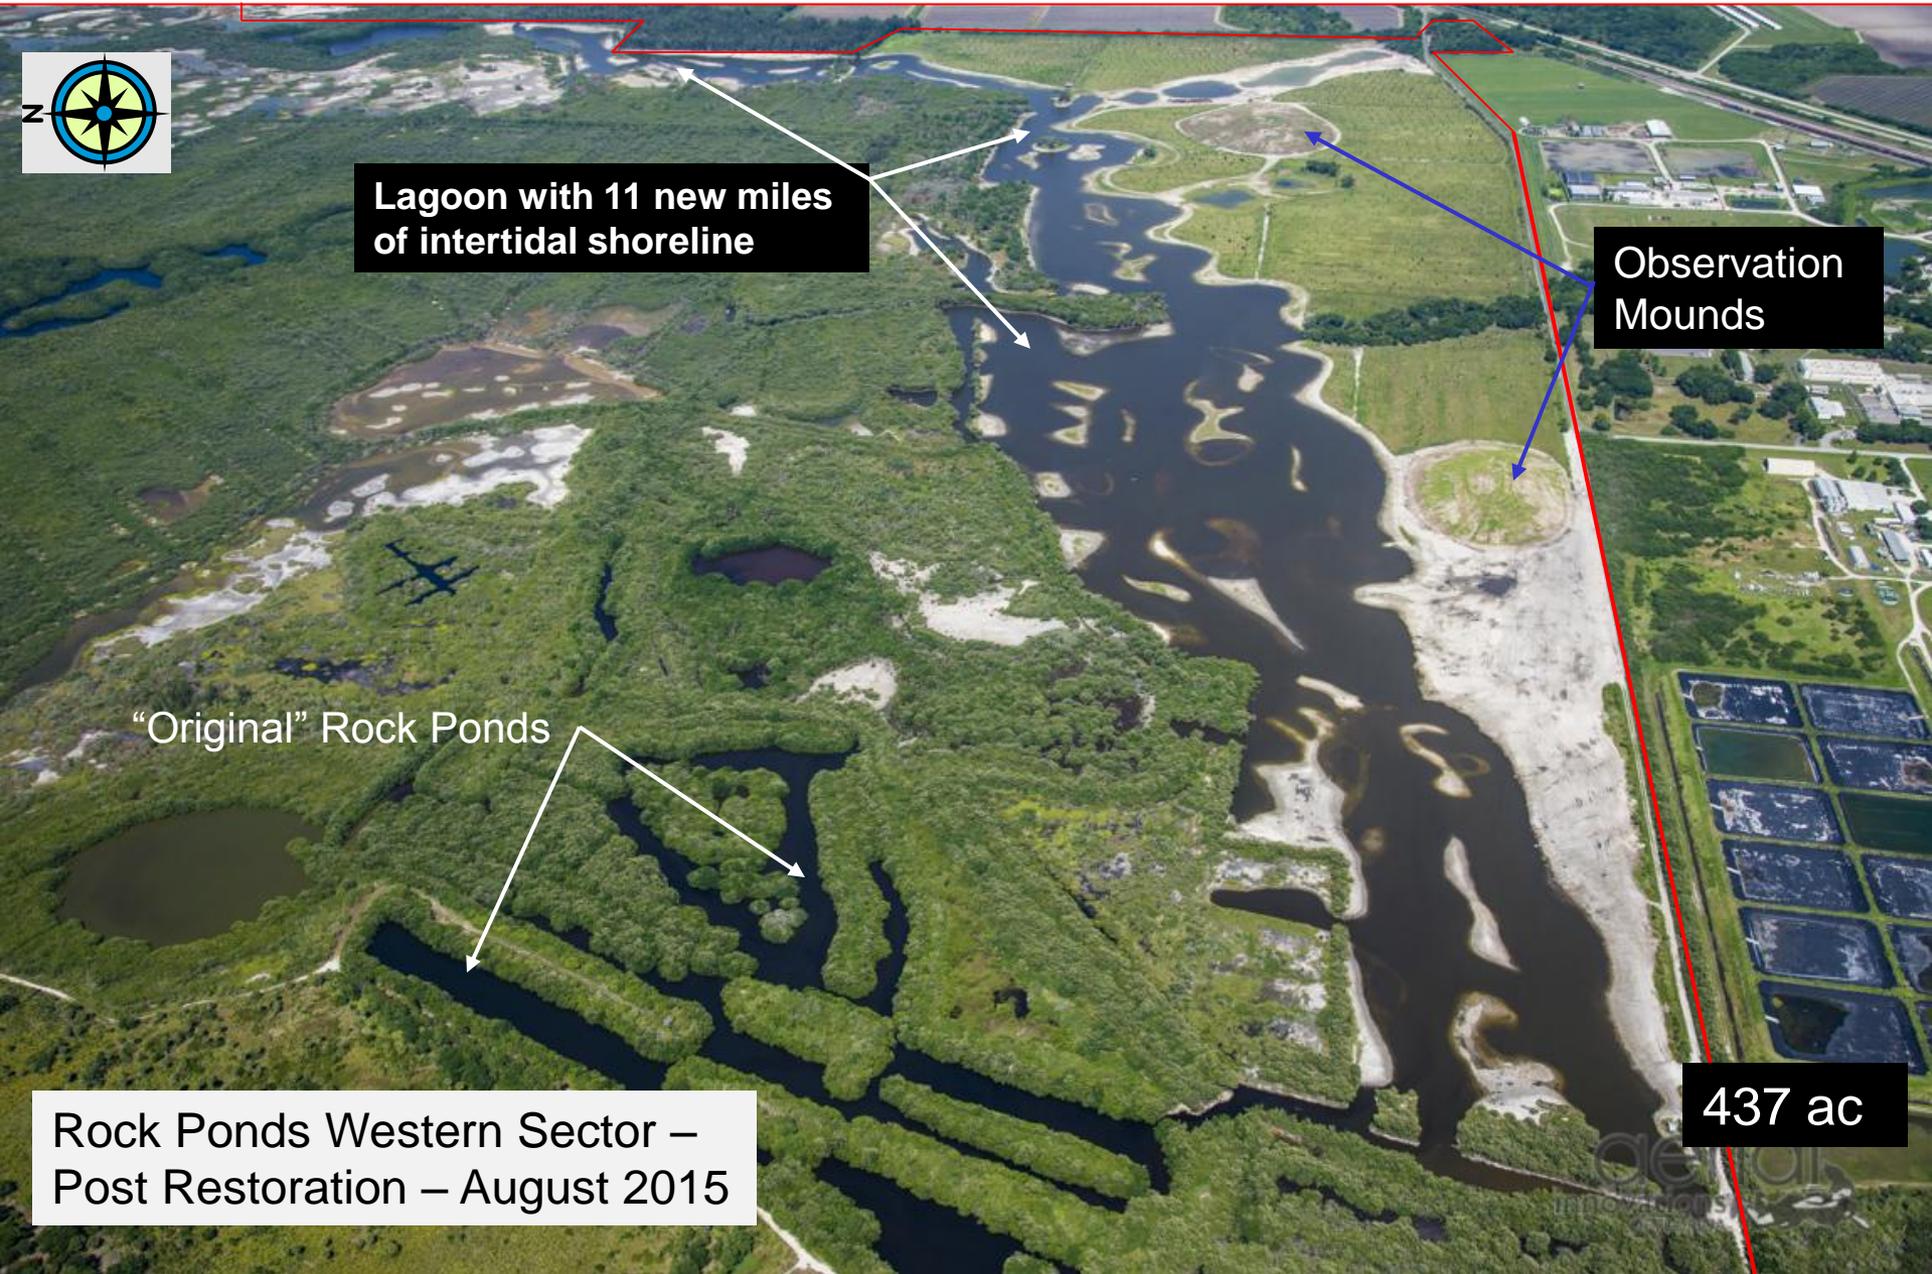
Lagoon with 11 new miles of intertidal shoreline

Observation Mounds

Rock Ponds Western Sector –
Post Restoration – August 2015

437 ac

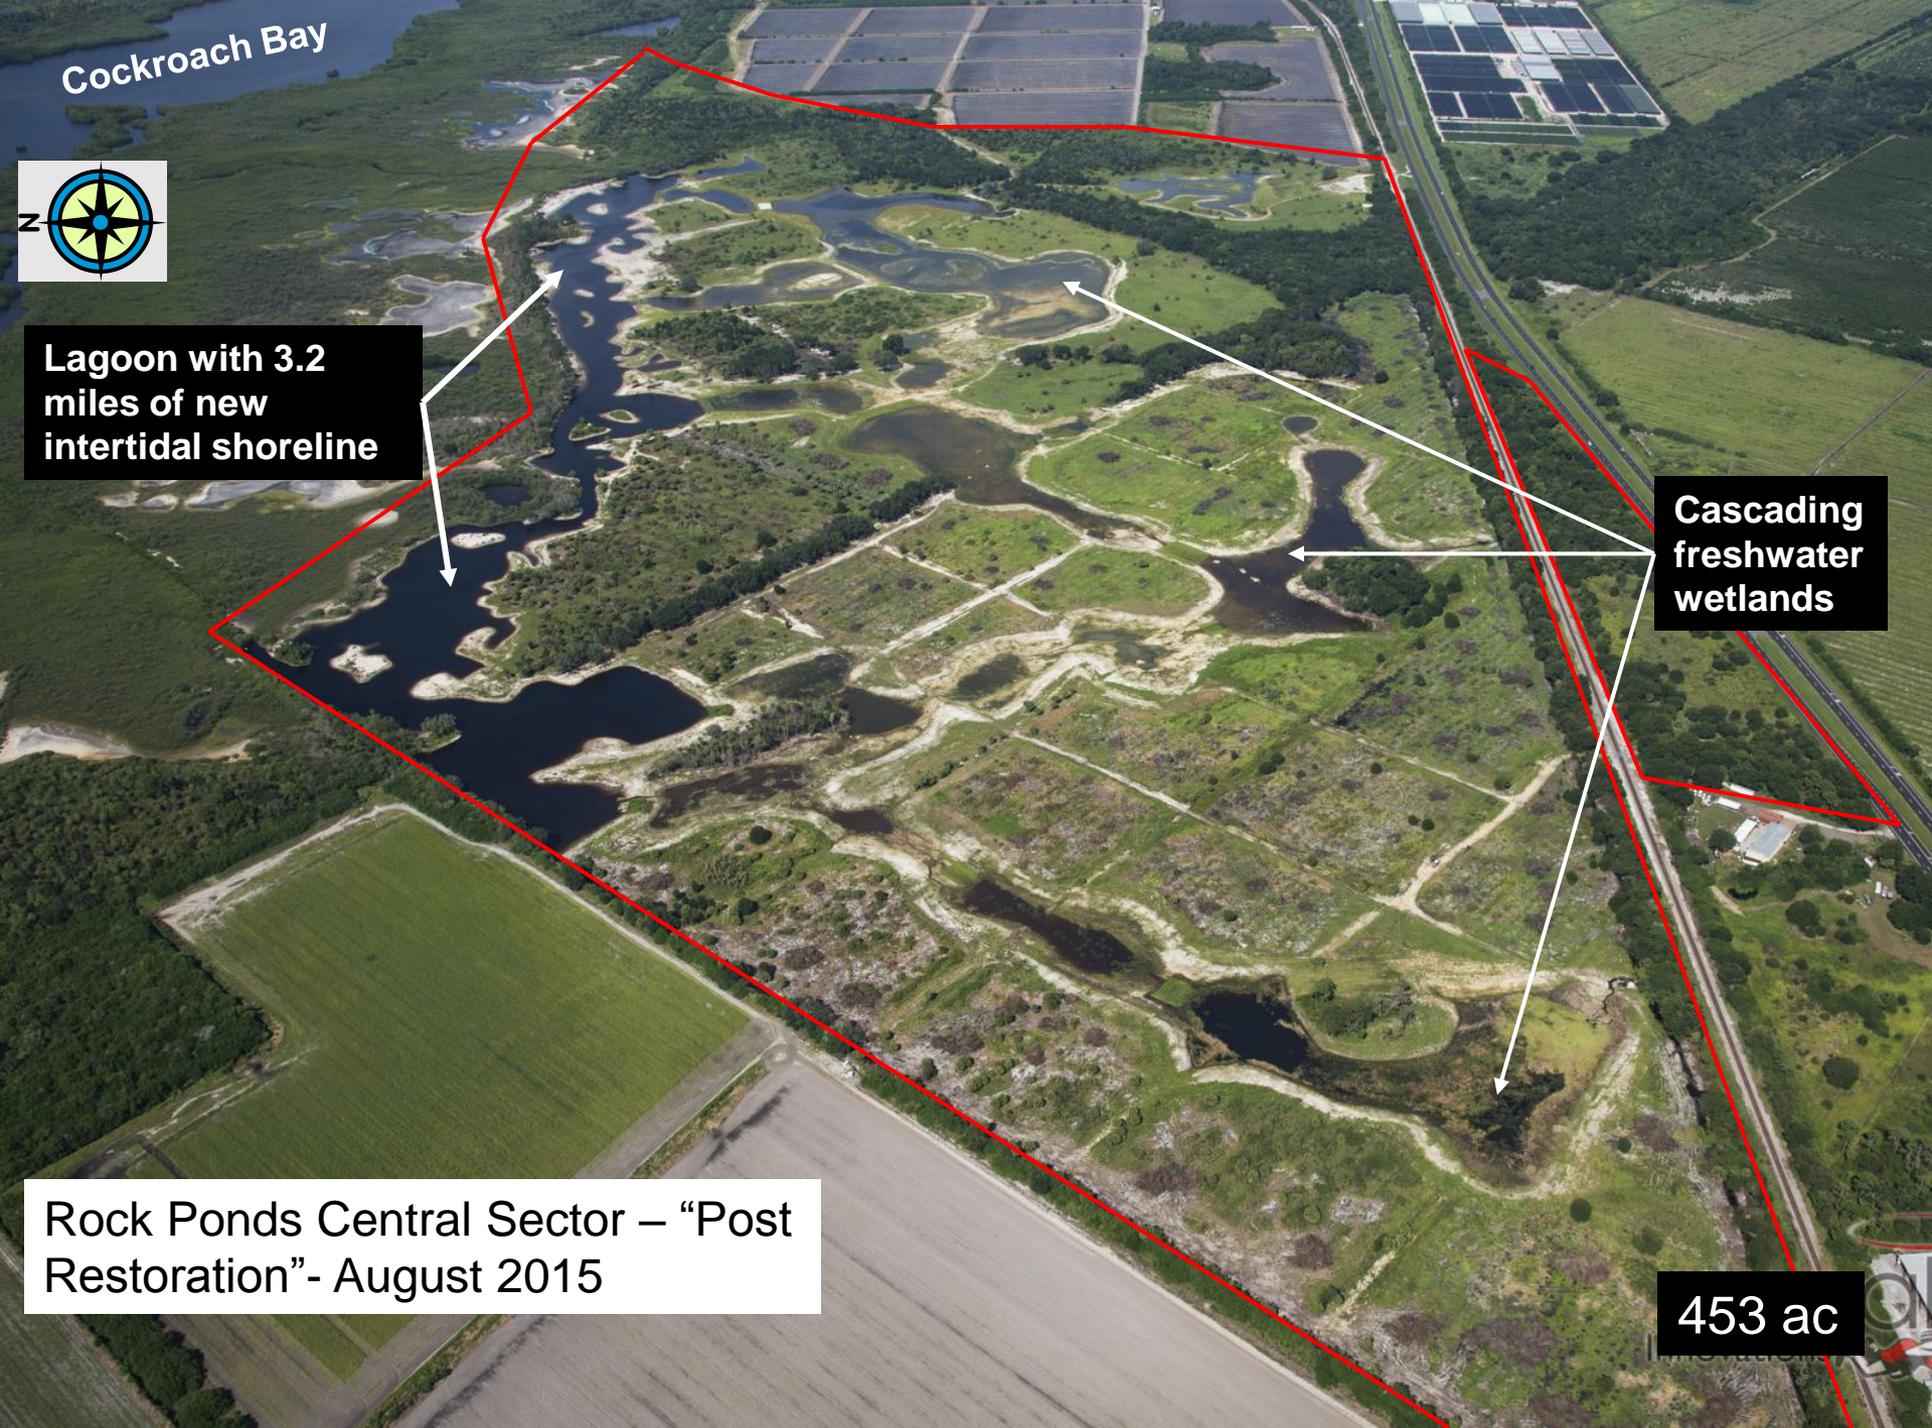
Lagoon with 3.2 miles of new intertidal shoreline

Cascading freshwater wetlands

Rock Ponds Central Sector – “Post Restoration”- August 2015

453 ac

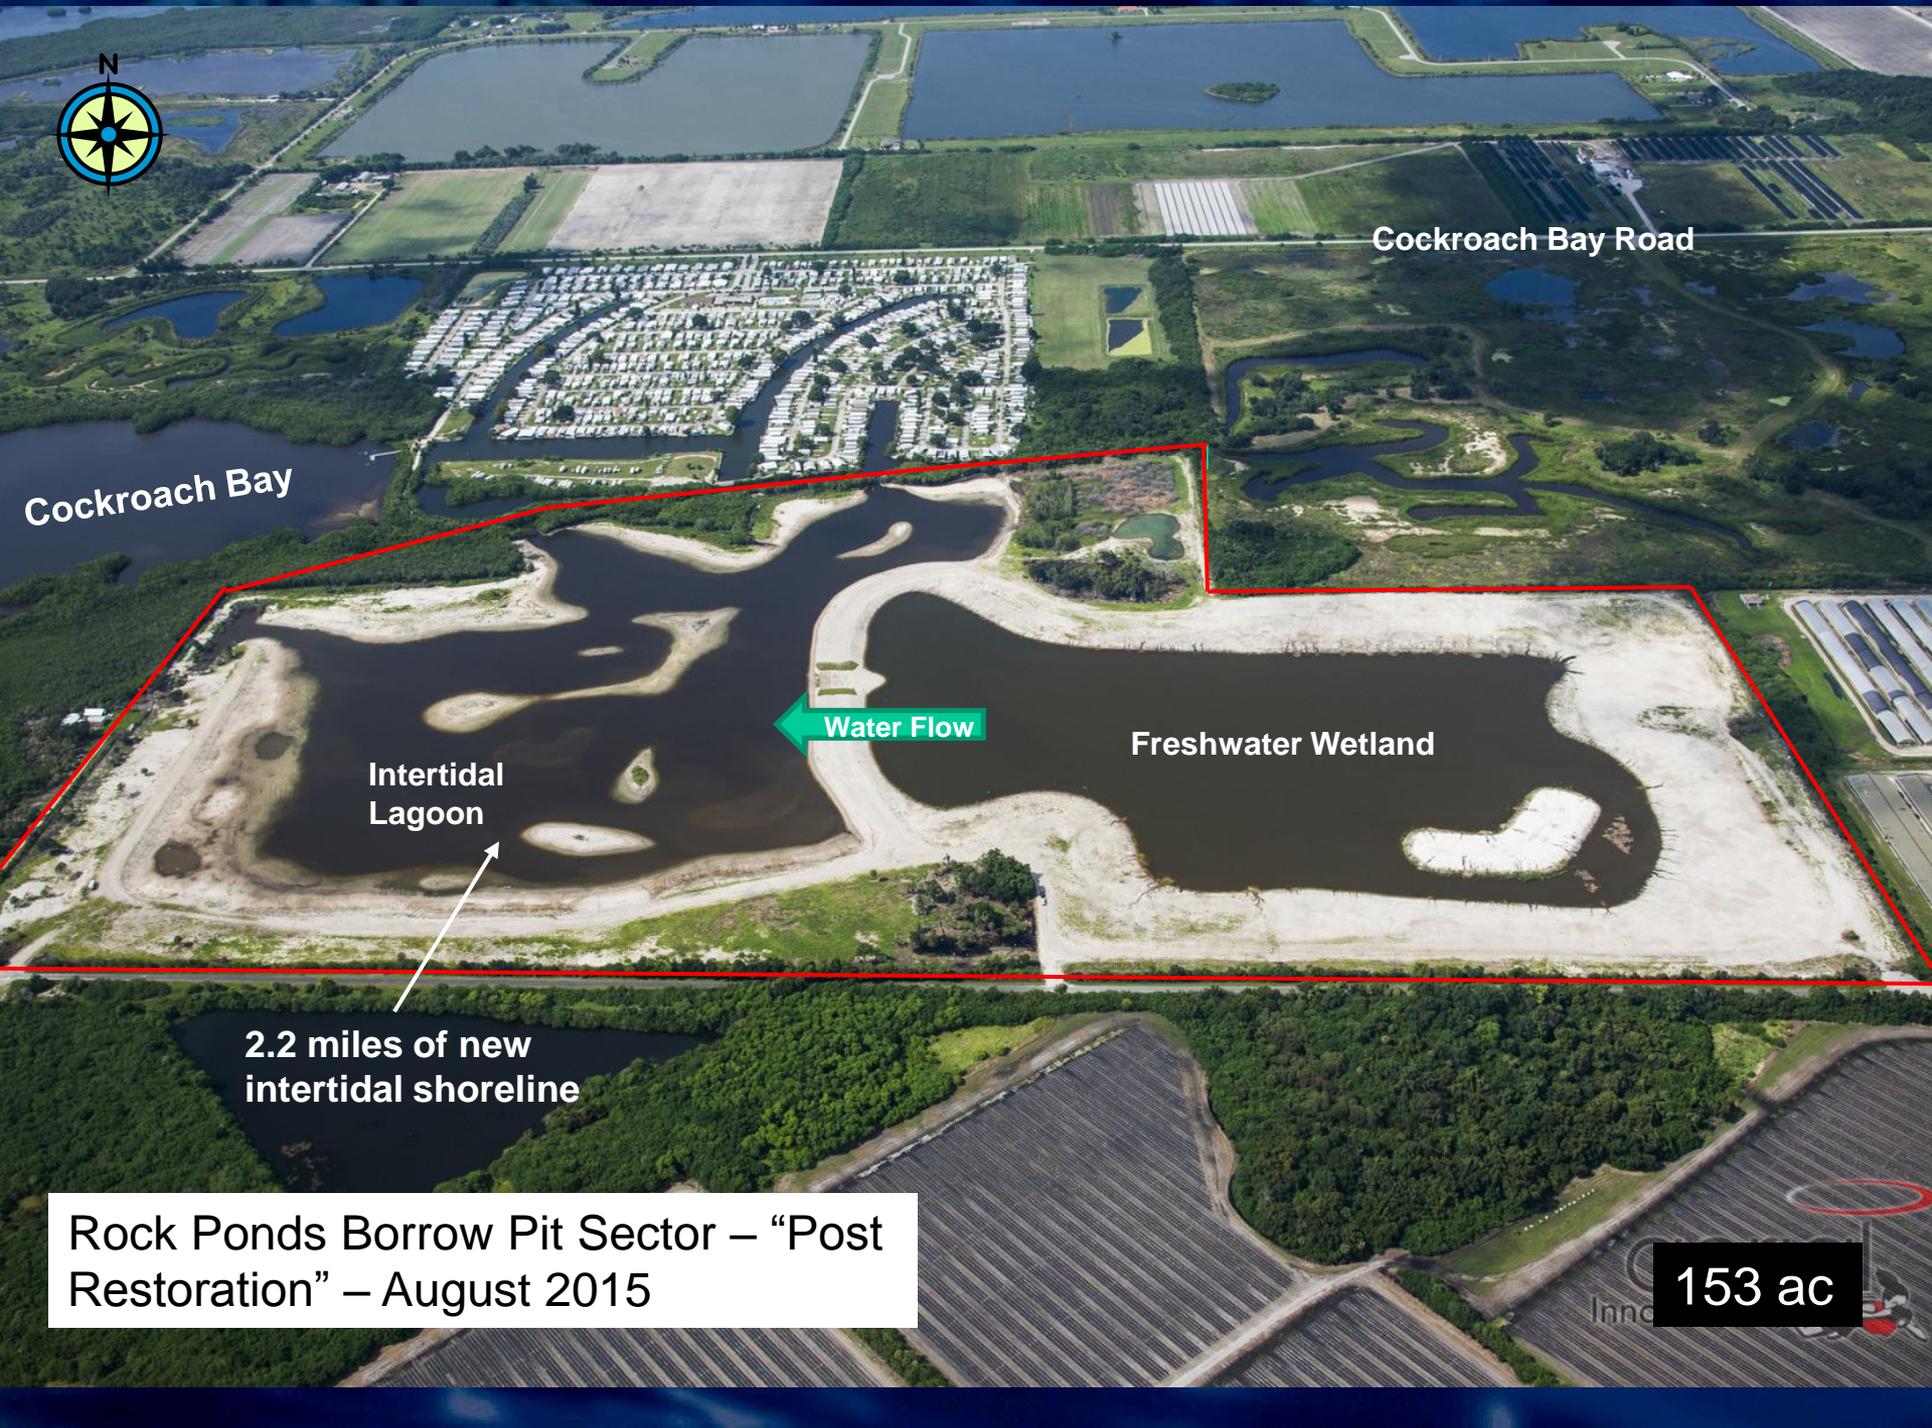
Water Flow

Freshwater Wetland

Intertidal Lagoon

2.2 miles of new
intertidal shoreline

Rock Ponds Borrow Pit Sector – “Post
Restoration” – August 2015

153 ac
